**POTENTIAL INCIDENTS
OF CONCERN**

**4, 6, 9, 11, 14, 15, 17, 18,
41, 42, 44, 47, AND 57**

**ACTION/NO ACTION
RECOMMENDATIONS**

April 15, 2004

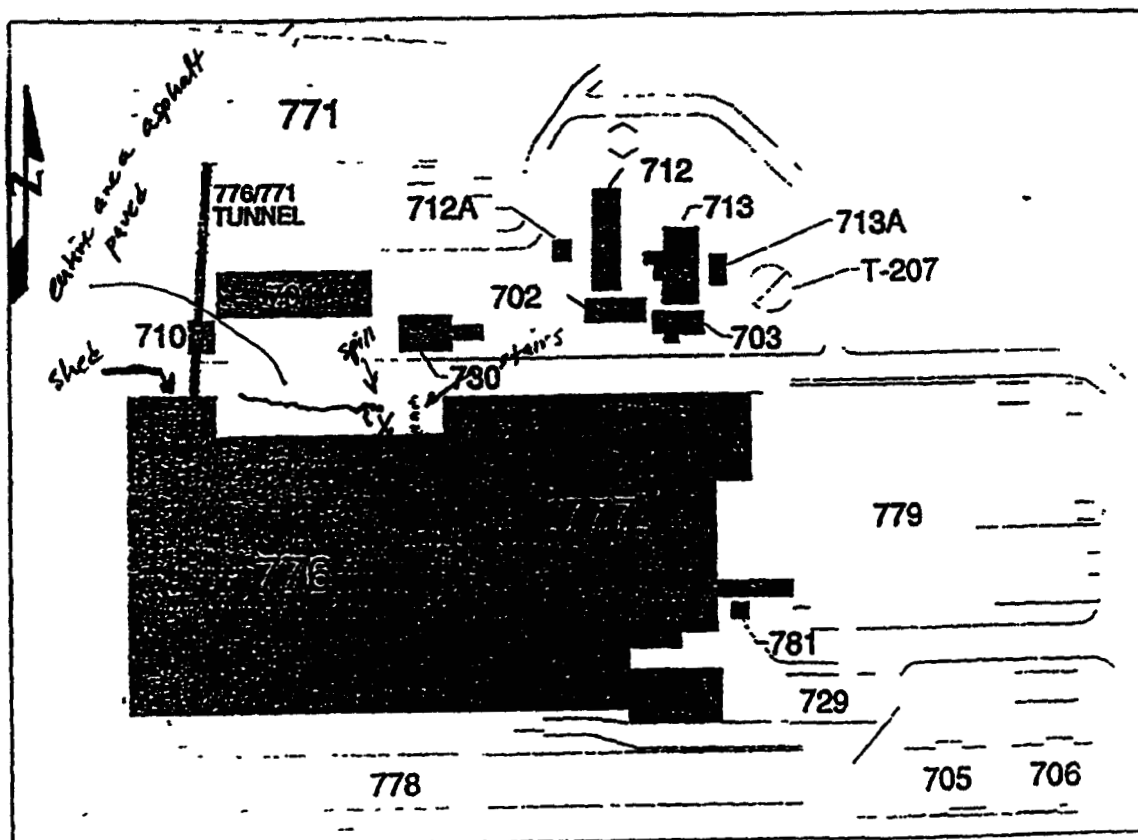
Figure 3. Building 776/777 Cluster Facilities

Although Building 776/777 subsurface soil was sampled in accordance with the IASAP Addendum IA-03-04 (IHSS Group 700-3), a sample was not collected below or near Building 781 (see attached map). However, considering the recent information gathered on the spill, sampling of the soil would not have been necessary.

Figure 3 shows the location of the buildings that comprise the Building 776/777 Cluster.

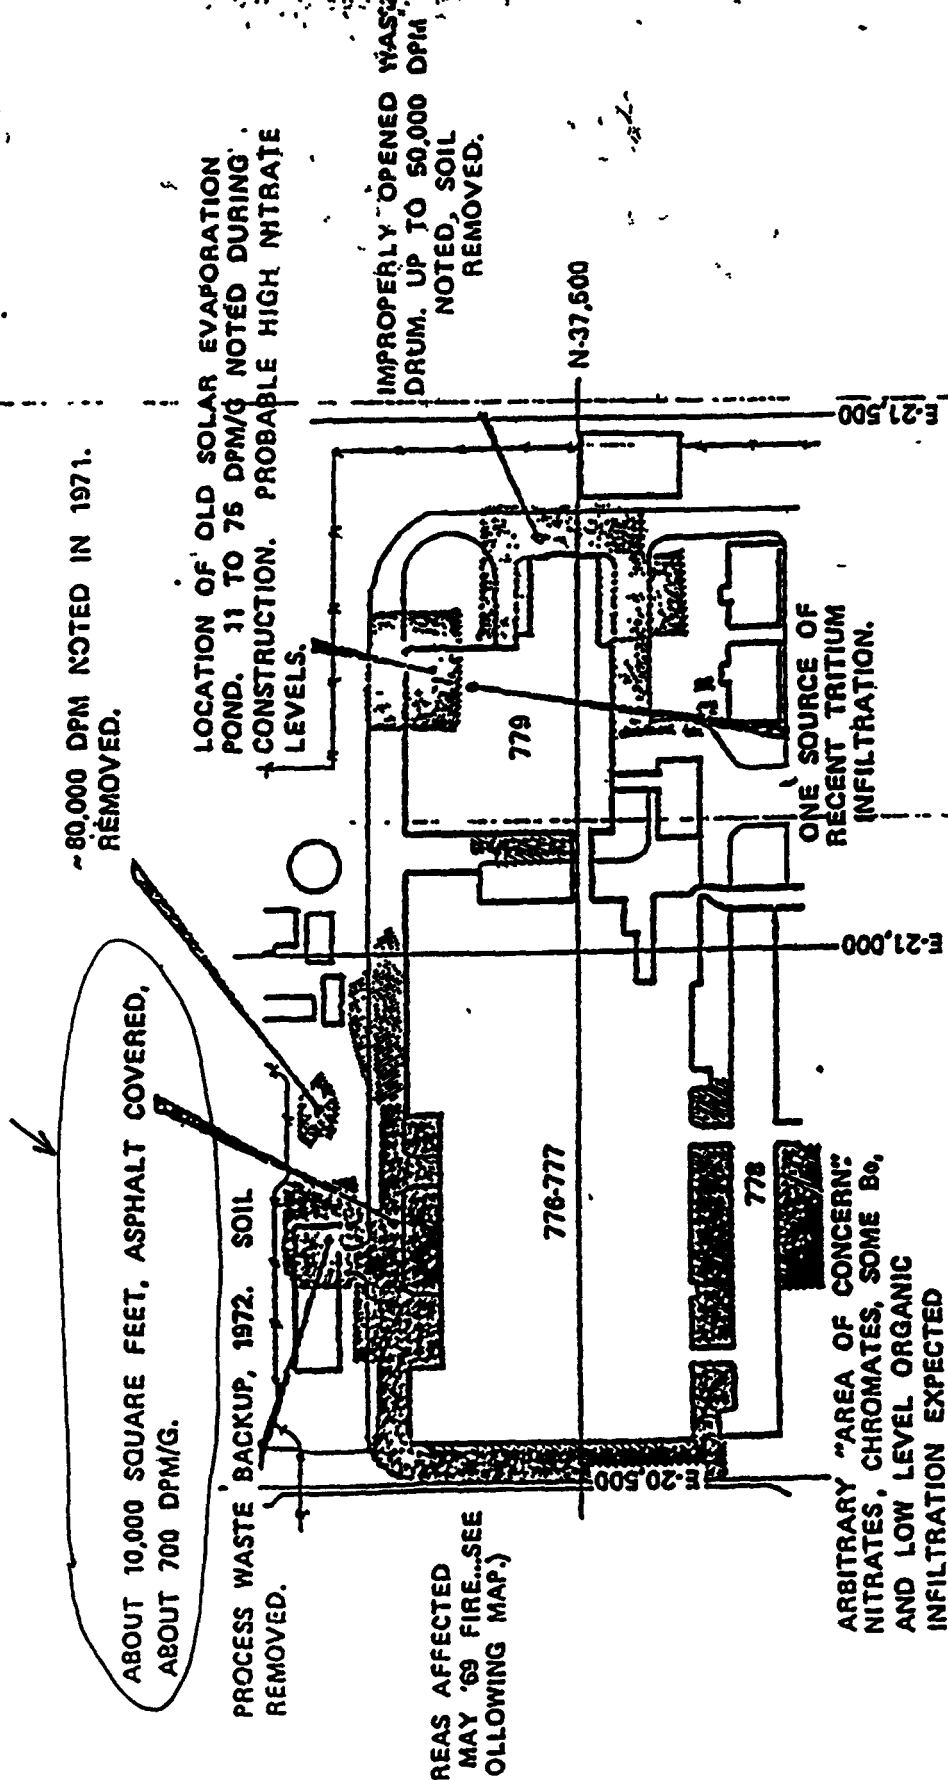
Owens 1974

- Pictures associated with the spill do not indicate Building 707 in the background. A recent site reconnaissance visit indicates that the spill took place on the northern side of Building 776 (see attached map and a photo looking south at B776, showing the stairs to the east and the shed to the west, which are two prominent features in the photos of the spill (also attached)). The photos of the spill indicate the diesel flowed a short distance north and then to the west. Although not clear in the spill photos, the entire area was paved because asphalt was placed over this area (adjacent to the building and the road behind the building) as a radiation control measure in response to the B776 fire (see attached map).² It is unlikely that a release of 28 gallons of oil migrated to an unpaved area. It is likely, the spill was cleaned up for practical/safety purposes, as this area appears well used.

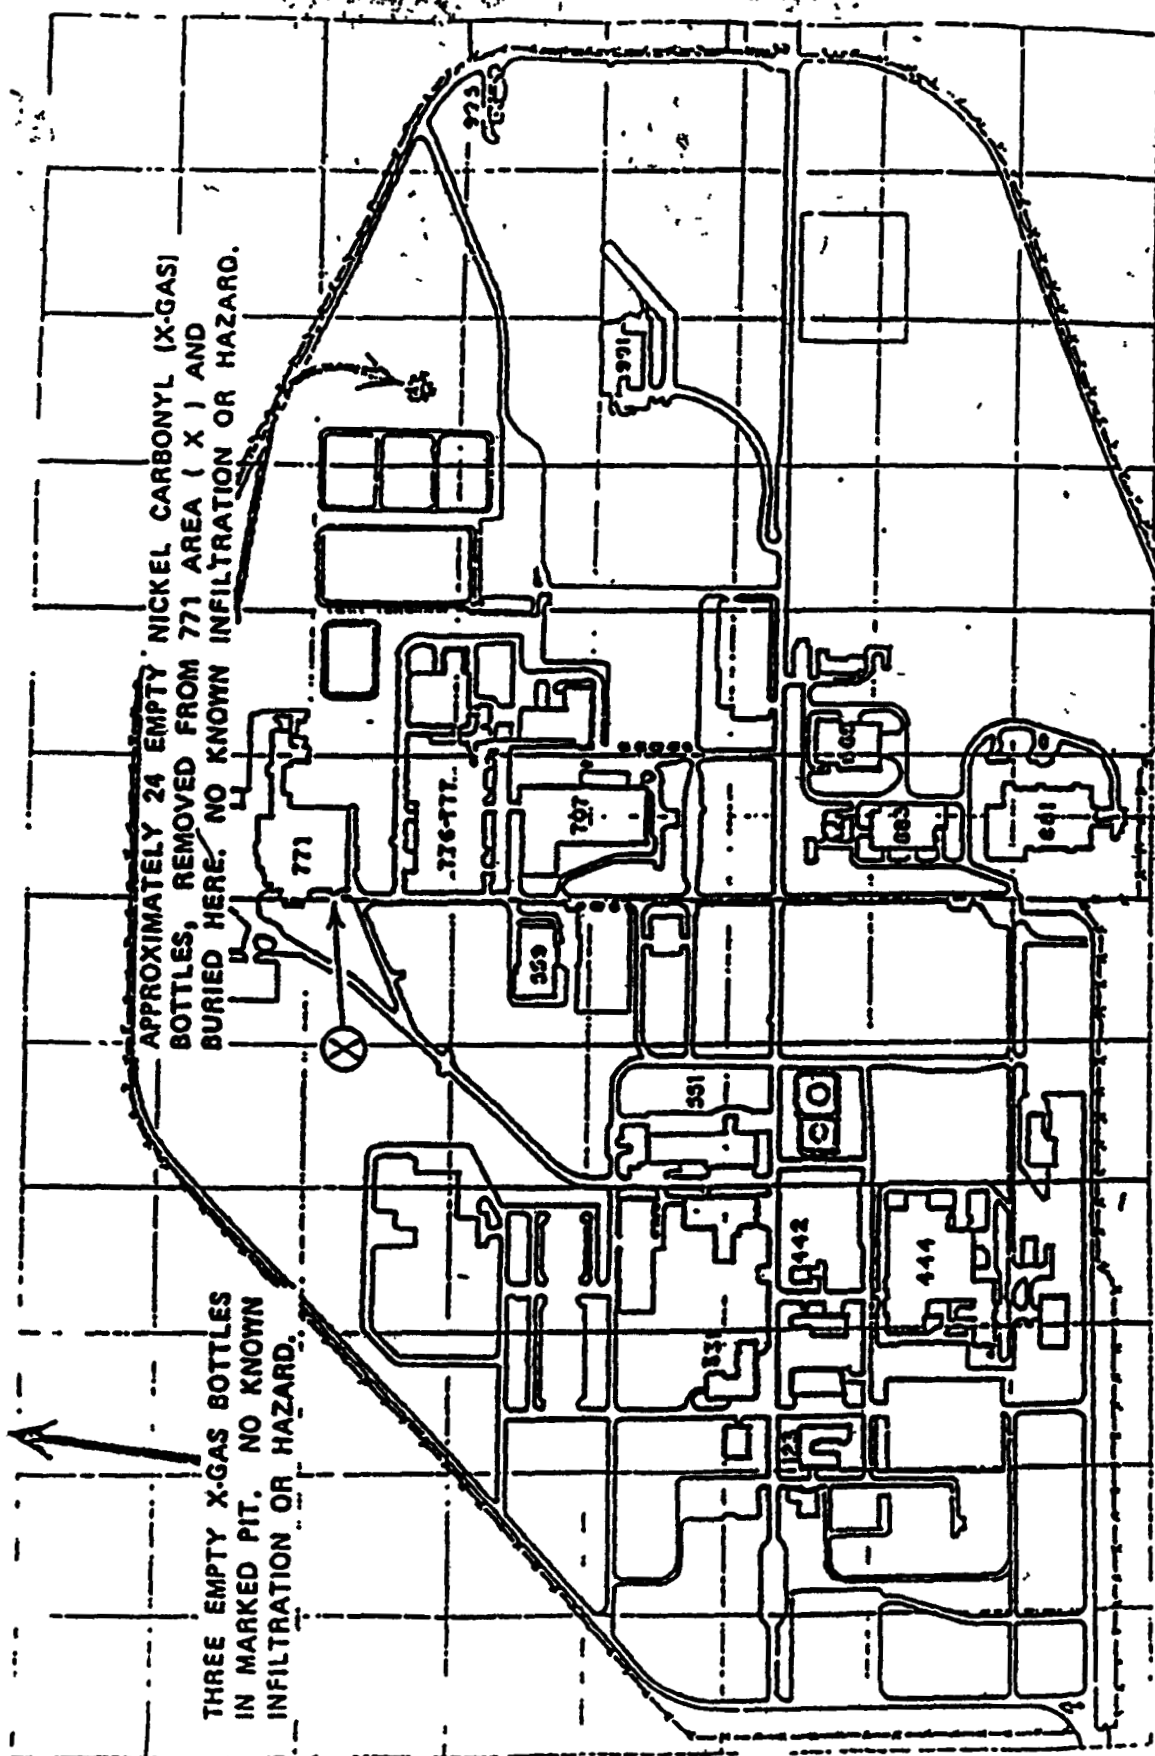
MAP 15A

Four 55-gallon drums, one GI can with two cylinders, and six loose cylinders of nickel carbonyl were removed from the burial pit west of Building 771 (PAC 700-1110) to a pit east of the Solar Evaporation Ponds Explosives charges were used to vent the containers ¹

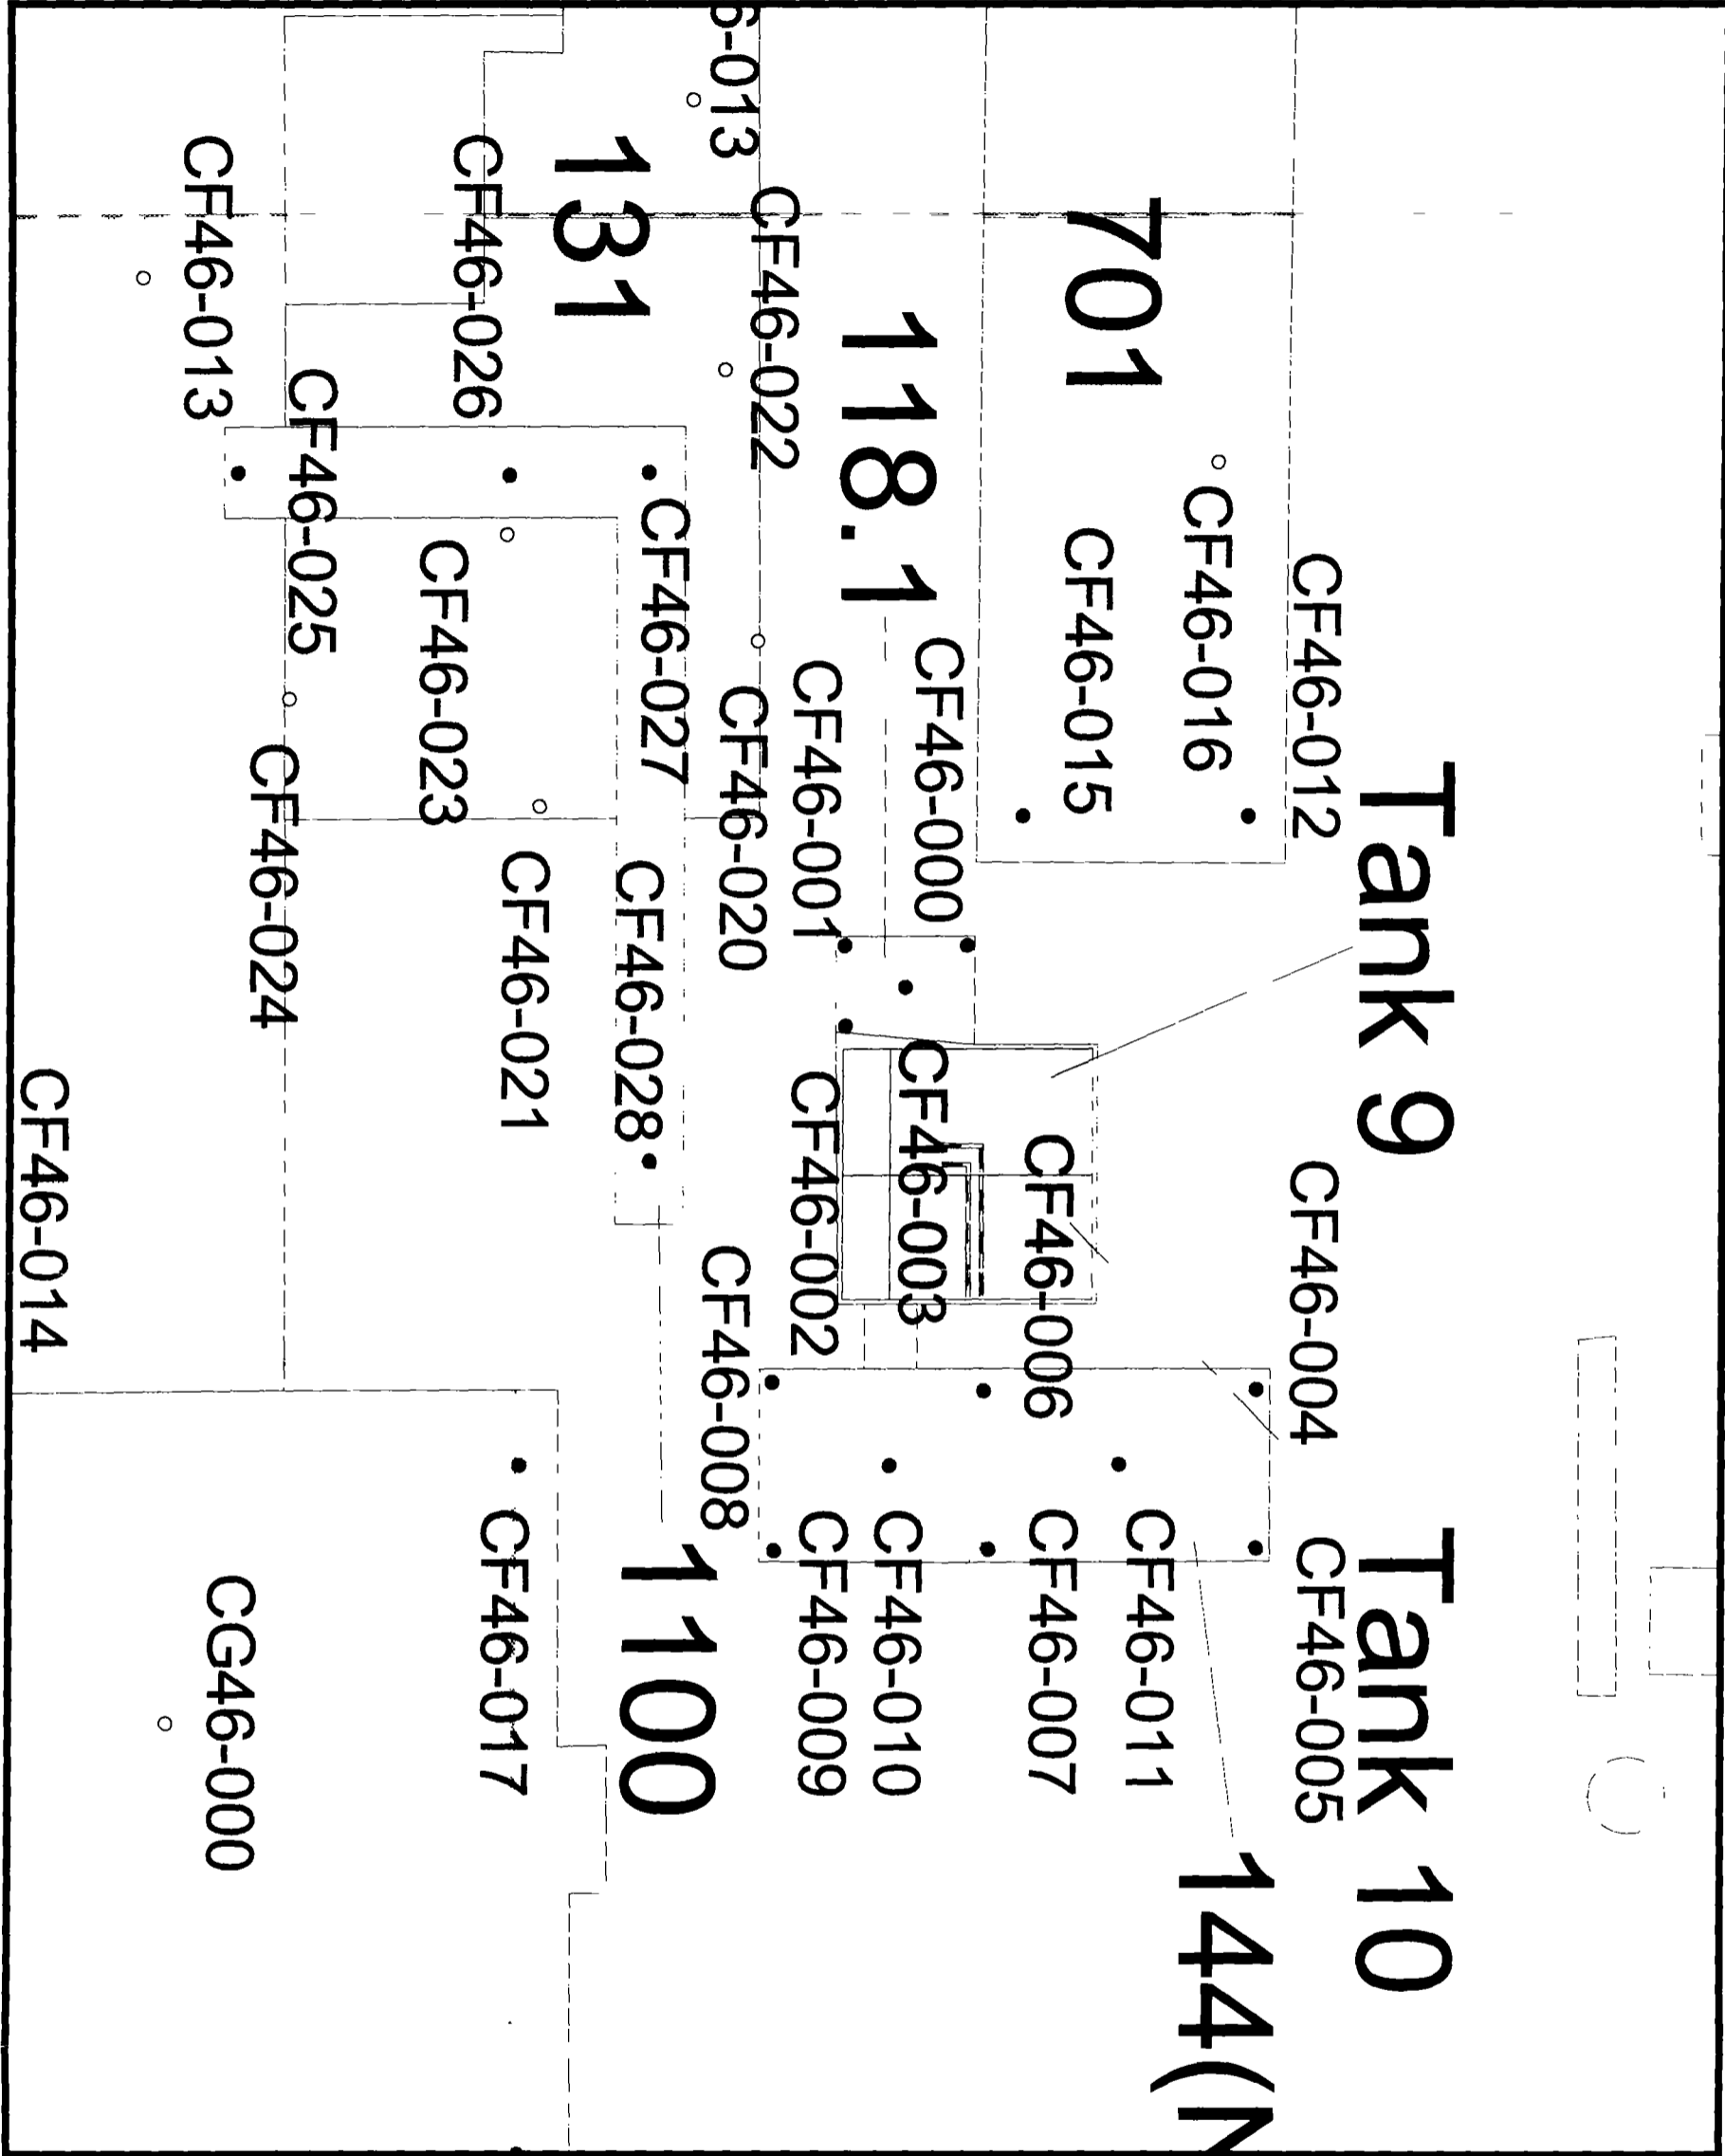
Figure 5
Proposed Sampling Locations
for IHSS Group 700 3

- The 5-gallon can was used to sample solvent in the 776 solvent storage area. The solvent storage area is PAC 700-118 1, underground carbon tetrachloride tanks on the west side of Building 730, north of Building 776. There have been numerous releases of carbon tetrachloride to the subsurface and to the ground surface at this location. PAC 700-118 1 is part of IHSS Group IHSS Group 700-3, and the area will be characterized through implementation of the IASAP Addendum for IHSS Group 700-3 (#IA-03-04) (see attached map). Because PIC 18 is within PAC 700-118 1, which is addressed under IHSS Group 700-3, no action is warranted for this PIC.
